# Naval Air Station Joint Reserve Base Willow Grove Wetland Delineation Report

A Technical Report in Support of the Environmental Impact Statement for the Disposal and Reuse of Naval Air Station Joint Reserve Base Willow Grove Horsham, Pennsylvania

Final

June 2013

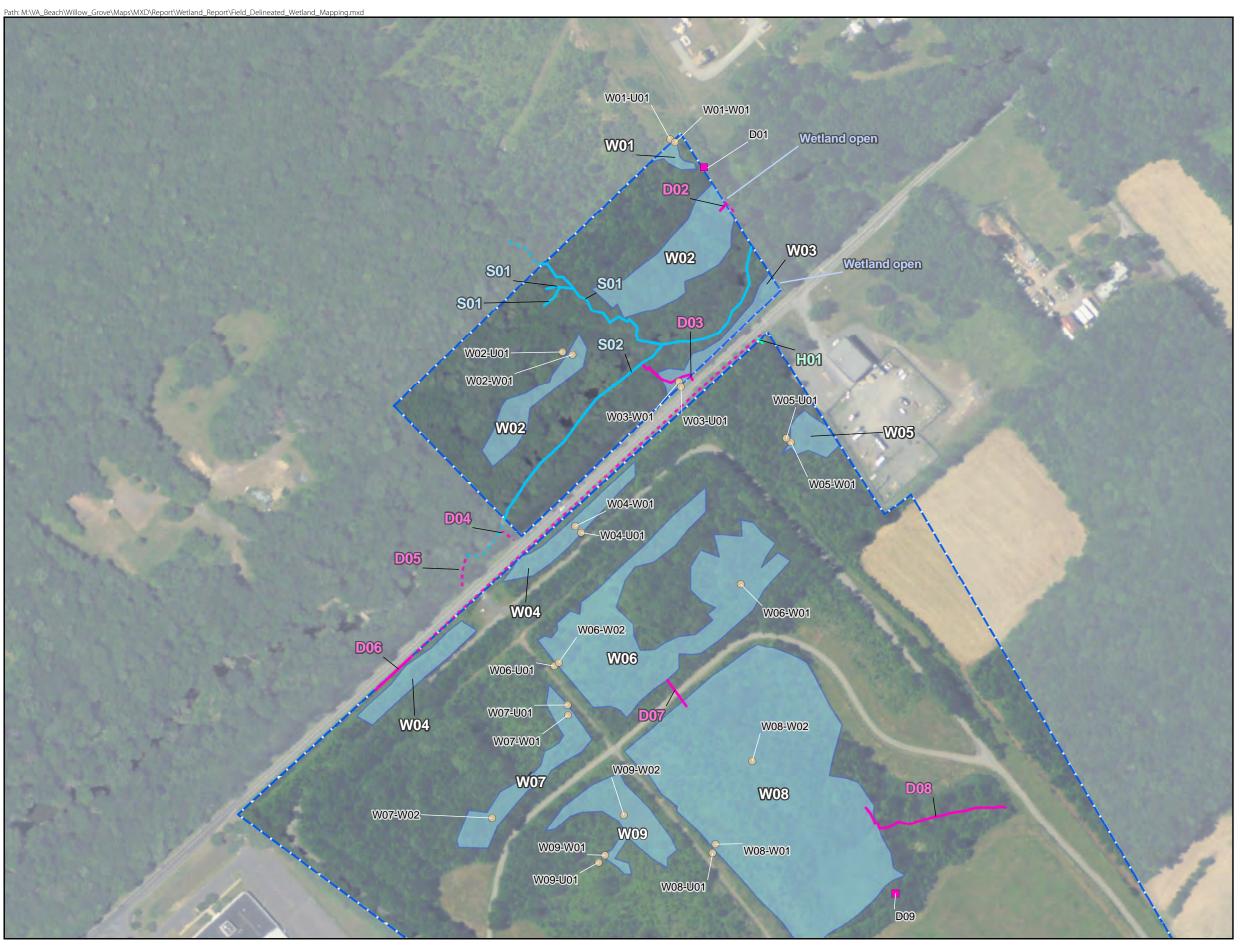
Frame 1 of 6 NAS JRB Willow Grove Horsham, PA

- Wetland W01: This 0.08 acres PEM1 wetland is located in the northeast corner of the property (see Figure 3-1, Frame 1). The wetland continues off the property to the north and receives hydrologic inputs from a retention pond located off the NAS JRB Willow Grove property. The wetland appears to have a discrete ephemeral connection to W02 and Park Creek (S02) via a swale (D01) that runs southeast, off the installation property. Dominant herbaceous species in the wetland include common fox sedge (Carex vulpinoidea), lesser poverty rush (Juncus tenuis), lamp rush (Juncus effusus), and common velvet grass (Holcus lanatus).

- Wetland W02: This 1.62 acres PFO1 wetland was delineated as two separate sections north of Keith Valley Road (see Figure 3-1, Frame 1). The western section encompasses 0.49 acres, and the eastern section encompasses 1.13 acres. The eastern section of the wetland continues to the east, off NAS JRB Willow Grove property. The wetland is located within the floodplain terrace of Park Creek (S02) and is bisected by a stream (S01) that flows south to Park Creek (S02). Each wetland section has a discrete ephemeral connection to S01. A swale (D02) is also present at the eastern end of the wetland that connects directly to Park Creek (S02). At the time of the survey, approximately 25 percent of the wetland was inundated or saturated at the surface. Dominant trees include silver maple (Acer saccharinum), American elm (Ulmus americana), and red maple (Acer rubrum). American elm, northern spicebush (Lindera benzoin), and rambler rose (Rosa multiflora) occur in the sapling/shrub stratum, and melic manna grass (Glyceria melicaria), thymeleaf speedwell (Veronica serpyllifolia), fig buttercup (Ficaria verna), and lamp rush occur in the herbaceous stratum.

- Wetland W03: This 0.30 acres wetland borders the north side of Keith Valley Road; it continues off of the installation property to the east (see Figure 3-1, Frame 1). The wetland connects to Park Creek (S02) through a drainage (D03) originating on the south side of Keith Valley Road. It is a PEM1 wetland close to the road, and transitions to a PSS1 wetland and PFO1 wetland moving north from the road. Green ash (*Fraxinus pennsylvanica*) is the dominant tree species and also occurs in the sapling stratum. Red osier (*Cornus alba*) also occurs in the sapling stratum. Herbaceous species include skunk-cabbage (*Symplocarpus foetidus*), lamp rush, fig buttercup, uptight sedge (*Carex stricta*), and sensitive fern (*Onoclea sensibilis*).

- Wetland W04: This 0.83 acres PSS1/PFO1 wetland is located along the perimeter fence on the south side of Keith Valley Road (see Figure 3-1, Frame 1). The wetland is bisected by a road and was delineated as two separate polygons; the western portion encompasses 0.41 acres and the eastern portion encompasses 0.42 acres. The two areas are connected by a culvert and drain into a narrow roadside ditch along Keith Valley Road (D06). A small hillside seep (H01) was also noted during the survey draining into D06. Culverts (D04 and D05) continue under Keith Valley Road and drain into Park Creek (S02). At the time of the survey, approximately 20 percent of the wetland was inundated. The wetland contains an abundance of trees up to 40 feet tall and saplings up to 20 feet tall. Silver maple, slippery elm (*Ulmus* rubra), and red maple dominate the tree stratum. Silver maple and slippery elm are also common in the sapling stratum, along with red osier and black willow (Salix nigra). The herbaceous stratum is dominated by common reed (Phragmites australis), sensitive fern, and field horsetail (Equisetum arvense).

- Wetland 07: This 0.66 acres PSS1/PFO1 wetland is situated in a depression created by bermed roads to the south and east (see Figure 3-1, Frame 1), which separate this wetland from W06, W08, and W09. This wetland was not inundated at the time of the survey; however, the soil was saturated to the surface and primary (i.e., oxidized rhizospheres) and secondary (e.g., drainage patterns) wetland hydrology indicators were observed. Forested portions of this wetland are dominated by red maple and eastern red-cedar in the tree stratum, and red maple, southern arrow-wood, and rambler rose in the sapling/shrub stratum. In the scrub-shrub portions of the wetland, red osier, green ash, crack willow, and red maple are common in the sapling/shrub stratum, and lamp rush, uptight sedge, thyme-leaf speedwell, Canadian goldenrod (Solidago canadensis), fowl manna grass (Glyceria striata), and arrow-leaf tearthumb (Persicaria sagittata) are common in the herb stratum.

- Wetland W09: This 0.71 acres PEM1/PSS1 wetland is situated in a depression created by bermed roads to the north and east (see Figure 3-1, Frame 1), which separate this wetland from W06, W07, and W08. The wetland appears isolated, as no outlets were observed during the survey. As with W08, W09 appears to have been cleared in the past, and contains emergent vegetation in the center with a scrub-shrub fringe. The center portion of the wetland was inundated at the time of the survey. The emergent portion of the wetland is dominated by rufous bulrush, uptight sedge, broad-leaf cat-tail (*Typha latifolia*), harvestlice (*Agrimonia parviflora*), blunt spike-rush (*Eleocharis obtusa*), and arrow-leaf tearthumb. Scattered saplings of green ash, slippery elm, and pin oak (*Quercus palustris*) are also present. The scrub-shrub fringe is dominated by pin oak, red osier, red maple, and slippery elm.

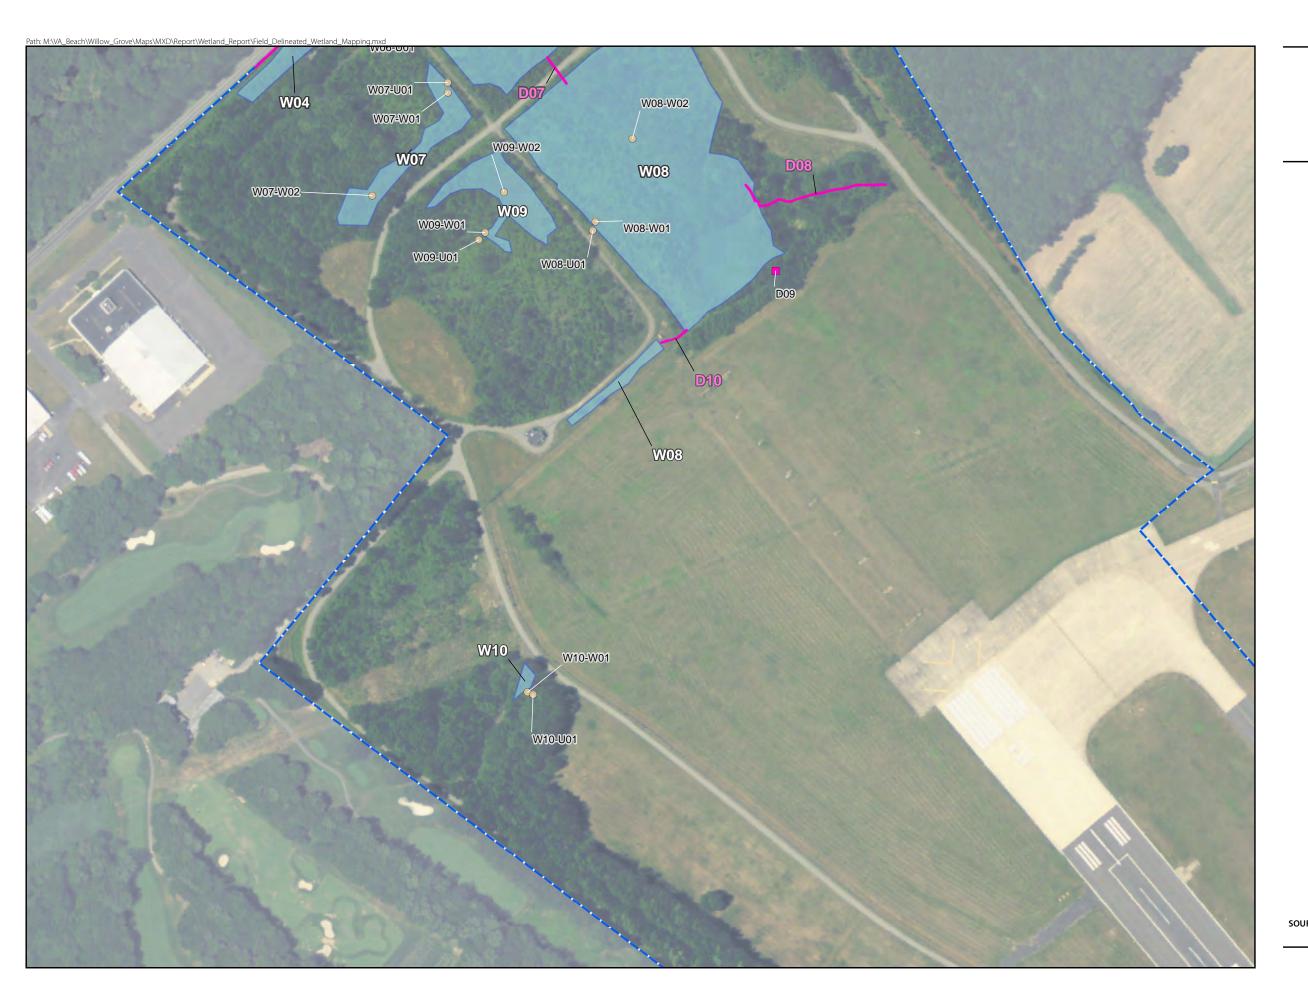
Frame 2 of 6 NAS JRB Willow Grove Horsham, PA

- Wetland W08: This 7.04 acres wetland has PFO1, PSS1, and PEM1 components (see Figure 3-1, Frames 1 and 2). As with other wetlands in this area (i.e., W06, W07, and W09), it is a depression bounded by bermed roads. A 0.18 acres portion of the wetland was delineated to the west of the main wetland area. This portion is a PEM1 wetland connected to the main wetland by a culvert (D10) (see Figure 3-1, Frame 2). D08 and D09 appear to be hydrologic inputs into W08. W08 drains into W06 through a culvert (D07); however, these wetlands appear to be isolated, as no outlet from W06 was observed. This wetland appears to have been cleared in the past, possibly for clear zone maintenance. Forested areas are dominated by red maple, silver maple, and green ash in the tree stratum; red osier, flowering dogwood, American plum (Prunus americana), red maple, green ash, southern arrowwood, rambler rose, and twinsisters (Lonicera tatarica) in the sapling/shrub stratum; and, soft fox sedge (Carex conjuncta), Japanese honeysuckle (Lonicera japonica), and rufous bulrush in the herb stratum. Scrub-shrub areas contain saplings of red osier, black willow, green ash, ash-leaf maple (Acer negundo), pin oak, and red maple. Common reed and rufous bulrush occur in the herb stratum. PEM areas of the wetland are almost entirely vegetated with common reed.

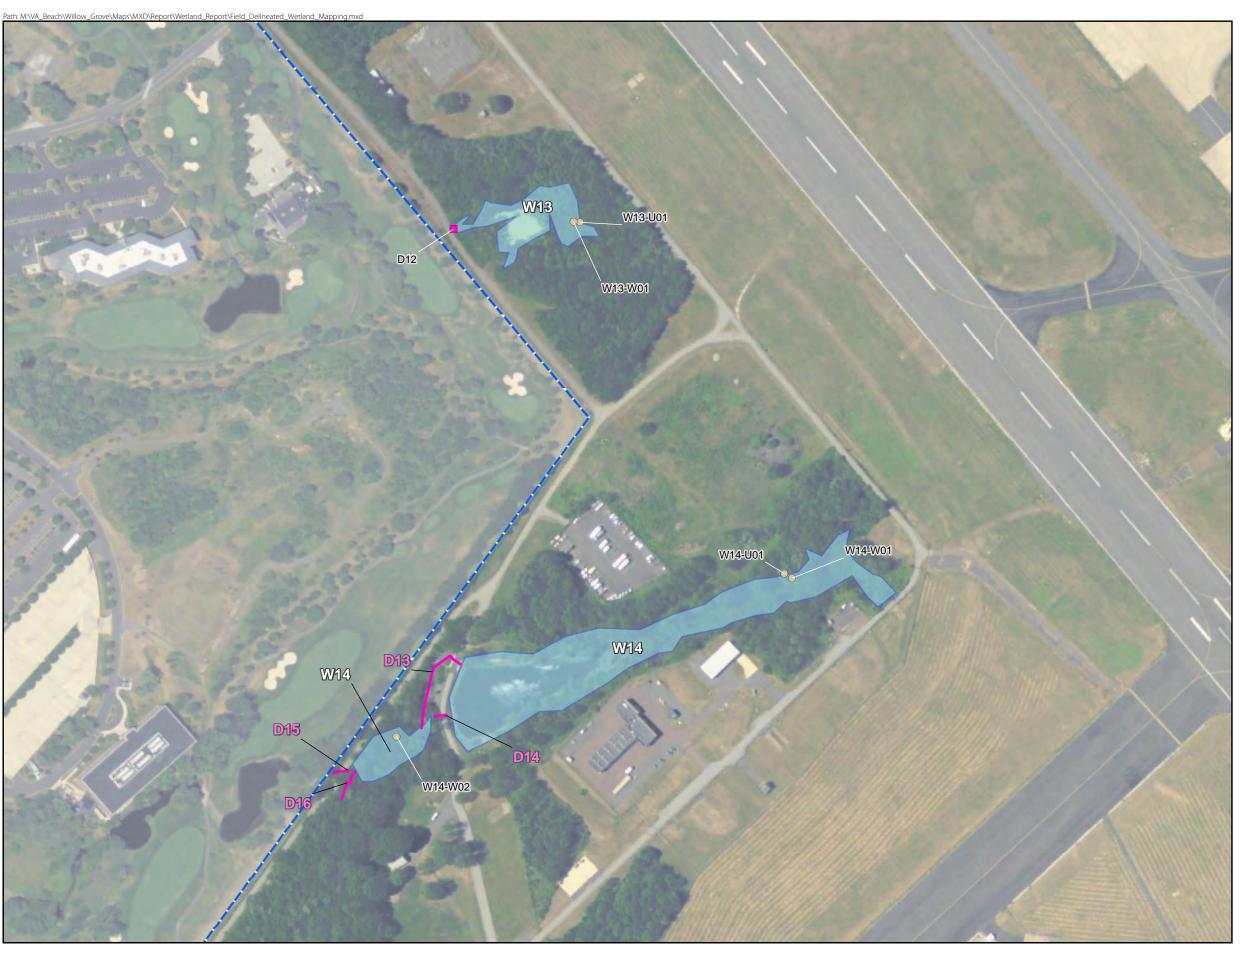
Frame 4 of 6 NAS JRB Willow Grove Horsham, PA

- Wetland W13: This 0.76 acres wetland is primarily a PSS1 wetland with areas of open water, but it contains some pockets of larger trees within its interior and along its fringe (see Figure 3-1, Frame 4). An old boardwalk and evidence of altered hydrology were observed during the survey. A previously mapped NHD stream was not located, likely as a result of the previous disturbance. However, a culvert (D12) was identified at the western end of the wetland that drains the wetland area under a road and off the installation. Larger trees include red maple, shag-bark hickory (*Carya ovata*), and crack willow. The scrub-shrub areas are dominated by red osier, red maple, and pin oak.

- Wetland W14: This 3.68 acres wetland contains PSS1/PEM1 and PFO1 wetlands and open water. It was delineated as two separate areas (see Figure 3-1, Frame 4). The eastern area encompasses 3.28 acres and consists of a mixed PSS1/PEM1 wetland to the east that flows into an open water pond to the west. The pond is dammed by a road on its western side. A culvert and spill gate (D13 and D14) drain water to the west into a 0.40 acres PFO1 wetland. The system drains southwest off the installation through a culvert (D15). An overflowing monitoring well (D16) was noted during the survey; water from this well was flowing north into the wetland. Beaver (Castor canadensis) activity was noted throughout this wetland system. The PSS/PEM portion of the wetland is dominated by red osier, crack willow, sensitive fern, and uptight sedge. The forested portions are dominated by red maple, green ash, and tuliptree (Liriodendron tulipifera) in the tree stratum.

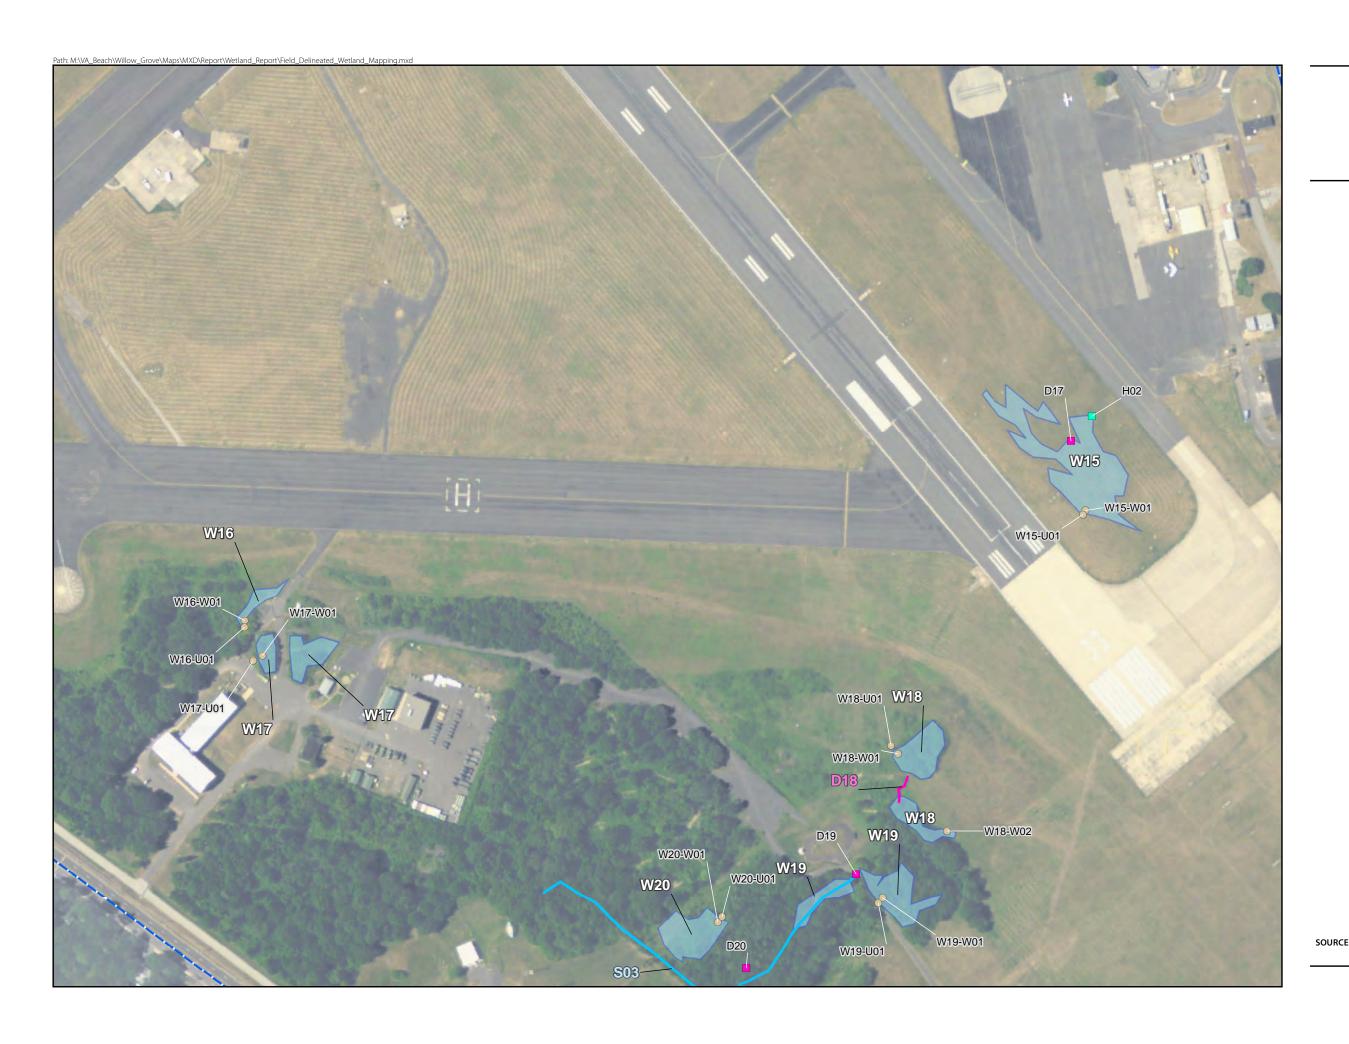
Frame 5 of 6 NAS JRB Willow Grove Horsham, PA

- Wetland W15: This 1.06 acres isolated PEM1 wetland is located in a depression between the runway and taxiway (see Figure 3-1, Frame 5). The size of the wetland is likely limited by a stormwater drain (D17), which drains the area during high water periods. At the time of the survey, soils within the wetland were saturated to the surface and inundated areas occurred in the interior. A seep (H02) was noted as a hydrologic input to the wetland. Dominant species include dark-green bulrush (*Scirpus atrovirens*), lamp rush, sallow sedge (*Carex lurida*), and slender spike-rush (*Eleocharis tenuis*).

- Wetland W18: This 0.44 acres mixed PSS1/PFO1/PEM1 wetland is located in the wooded margins of the airfield (see Figure 3-1, Frame 5). It was delineated as two areas connected by an upland swale (D18). The northern portion encompasses 0.28 acres, and the southern portion encompasses 0.16 acres. While the two portions are connected to each other, the wetland appears to be isolated. Forested areas contain crack willow and red maple in the tree stratum and red osier, crack willow, and red maple in the sapling/shrub stratum. PSS and PEM areas contain saplings of crack willow and red osier, with lamp rush, uptight sedge, and field horsetail in the herb layer.

- Wetland W19: This 0.5 acres PFO1 wetland is drained by a stream (S04) (see Figure 3-1, Frames 5 and 6). It was delineated as two areas connected by a culvert (D19), which conveys a stream (S04) under a paved path; an additional culvert (D20) also feeds into this stream. During the survey, an overflowing well or manhole cover (H03) was noted providing additional hydrologic input to S04. S04 drains from the installation via a culvert (D22). The eastern portion of the wetland encompasses 0.34 acres, and the western portion of the wetland encompasses 0.16 acres. Dominant trees include red maple and green ash; red osier and red maple are common saplings.

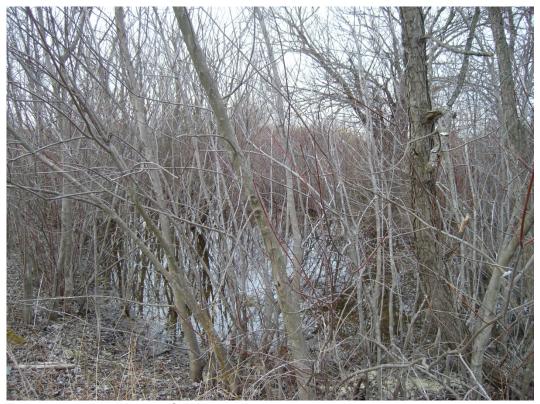
**Representative Photo of W17**

- osier and crack willow in the shrub stratum, and rufous bulrush, lamp rush, and Canadian goldenrod in the herb stratum.
- Wetland W17: This 0.30 acres isolated PSS1 wetland was delineated as two separate areas, as it is divided by a road (see Figure 3-1, Frame 5). The western portion encompasses 0.10 acres, and the eastern portion encompasses 0.20 acres. Both portions were inundated at the time of the survey. The sapling/shrub layer is dominated by pussy willow (*Salix discolor*), crack willow, and red osier; the herb layer is dominated by common reed.
